# **Sample Infrared Roof Inspection**

**Completed by Chad Board**

Modified Bitumen Roof

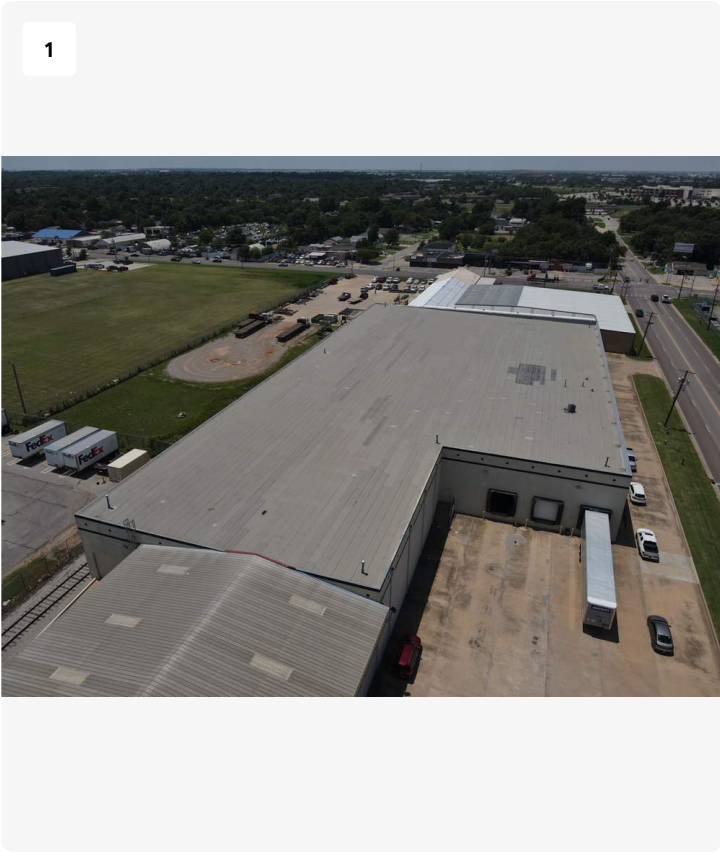
Overview of roof inspected

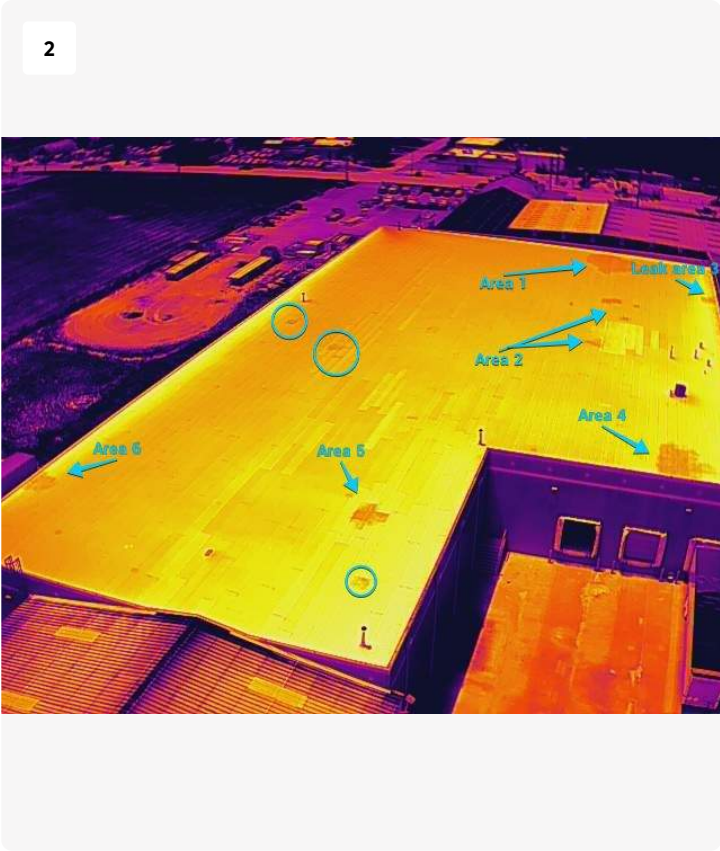
6 areas of potential leaks identified  
Additional possible issues circled

Please note all possible leak locations should be confirmed with with additional non-destructive testing (Tramex) or with destructive testing (core sample).

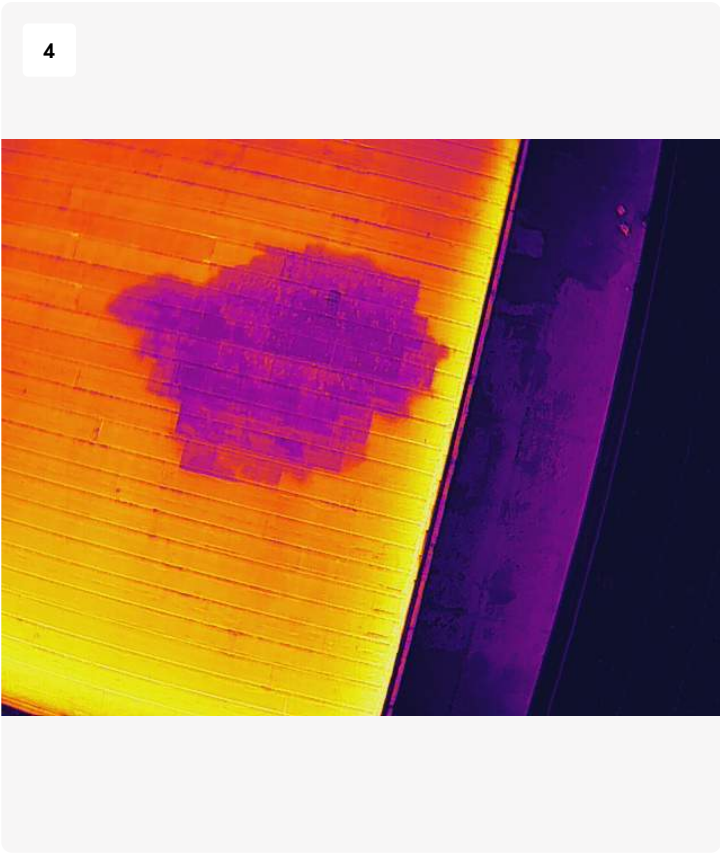
Due to high temperature on the roof and principles of thermal crossover, water in system was cooler than surface. This allowed the infrared identification of possible leak locations.

Area 1 - Potential moisture

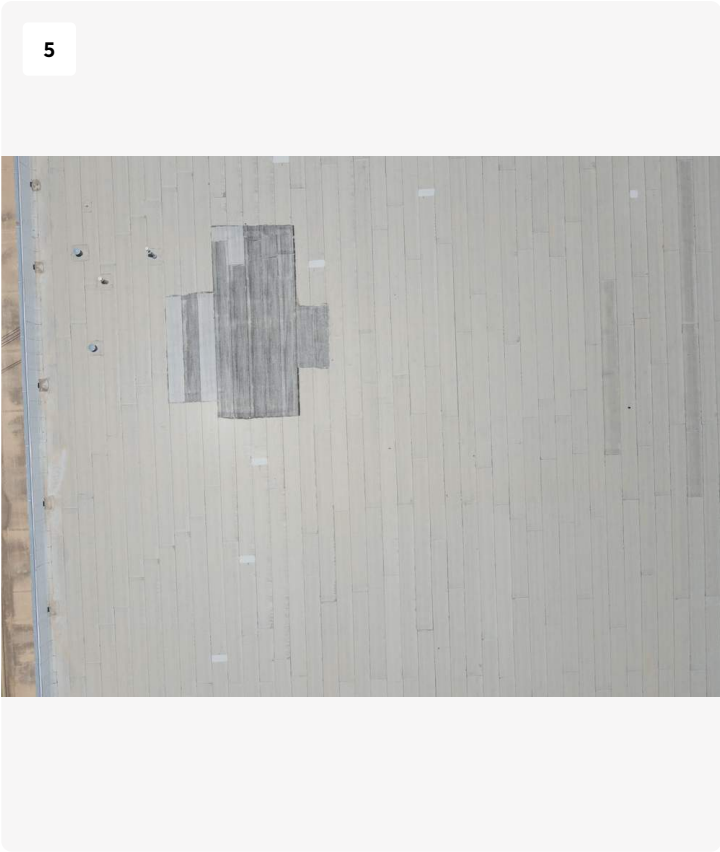
Note patch area  
Area 2

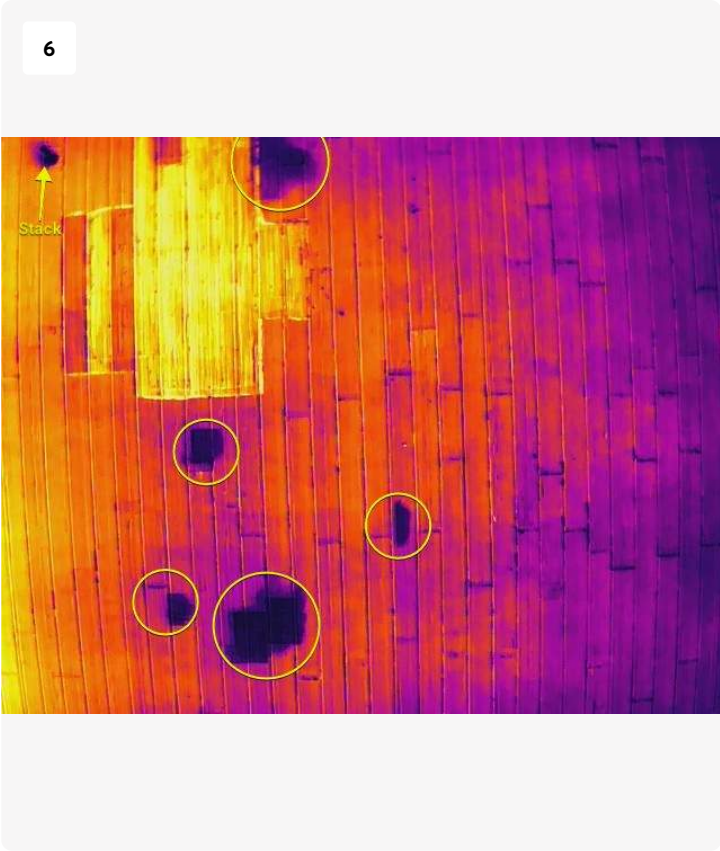
This area defined as area 2.  
Multiple possible moisture areas.  
Easily identified by patch area as identifying feature.
